Scottish Riley Enthusiasts Workshop

The Final Solution: 12/4 Hot Spot Tubes

Gordon McAllan

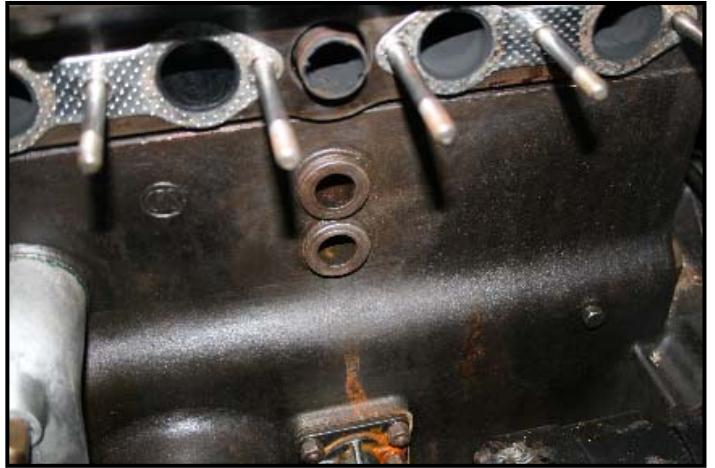
RH (driver's) side of block, after removal of inlet manifold. On this car, the flanged ends on this side are notched for a socket.

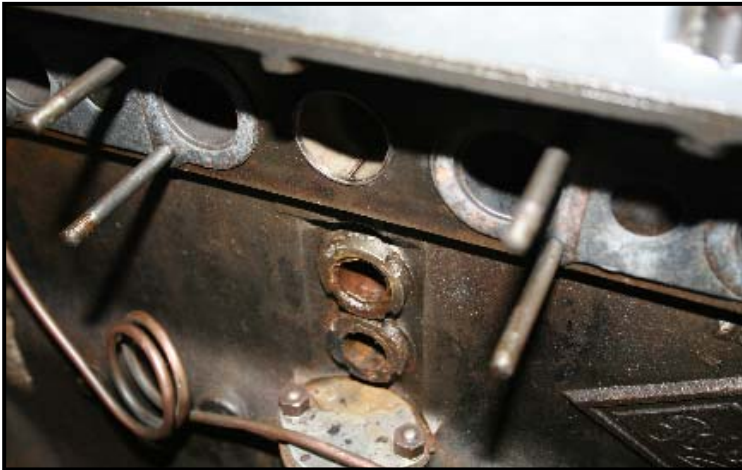
LH side of block, showing the upper of the two lower hot spot tubes being withdrawn, still with threaded and copper washers.
