Scottish Riley Enthusiasts Workshop

The Final Solution: 12/4 Hot Spot Tubes

Gordon McAllan

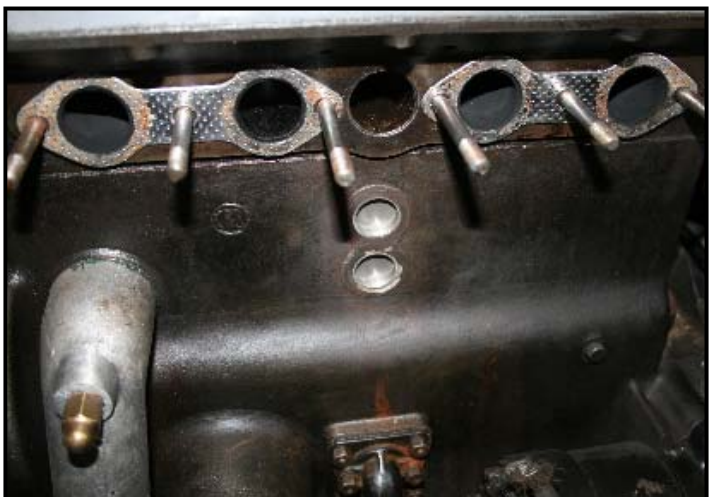
LH side of the block, after fitting of 1-inch stainless steel cup-type core plugs, to seal the holes in the casing left by removal of the hot spot tubes. The result is neat and effective. Full leak-free coolant circulation in the water jacket is restored. Both inlet and exhaust manifolds can now be refitted, the latter sealed where its inner hot spot tubes used to be located. The cooling system, block and radiator, must be flushed - preferably backflushed - before being filled with 50% anti-freeze for all-year motoring.

The four 1-inch O/D stainless steel cup-type core plugs arrived promptly and it was a short task to clean the hot spot tube holes in the block, smear them with gasket sealant just in case, and tap the plugs carefully into place. It is essential to drive each squarely, to prevent distortion and possible subsequent water leakage - after all, the object of this whole operation is to stop leaks! A short length of dowel or hand-tapered wood is ideal for this purpose, initially, though I found that an unworn, level-headed hammer, used lightly but firmly, made the final 1/4 - inch of insertion a positive and "clean" job. No hamfisting, mind!
